ASSUNPINK DAM

NO. 4

NJ 00322

**PHASE 1 INSPECTION REPORT
NATIONAL DAM SAFETY PROGRAM**

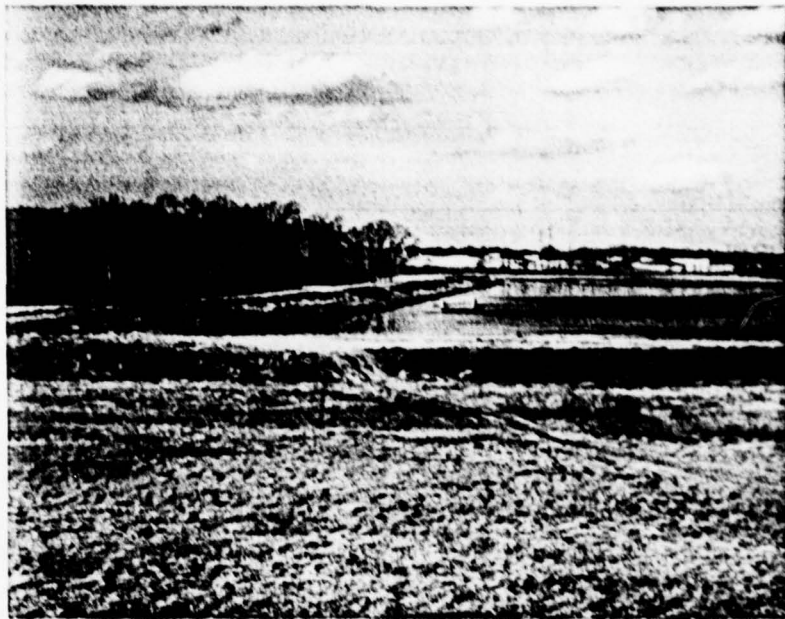
Overview of dam

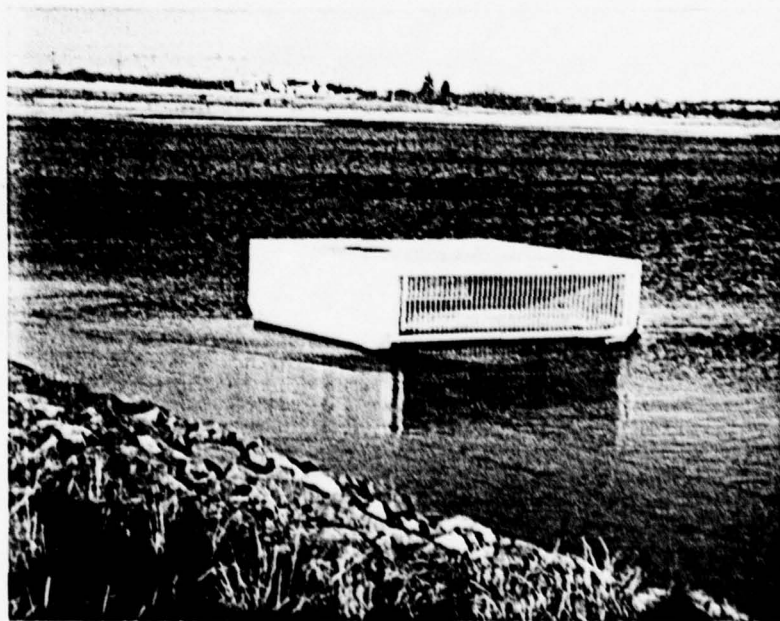
Although the location of the intake structure (22 feet offshore) precluded a close visual inspection, the concrete, grates, and trash racks appeared to be in excellent condition. The wheel to the grate stem was missing, but the representative of the Bureau of Fish and Game advised the inspection team that the wheel is removed to prevent vandalism. The grass cover on the auxiliary spillway appeared in good condition with the exception of the erosion gullies and vehicle tracks. The impact basin also appeared to be in good condition and functioning as designed.

View of intake structure

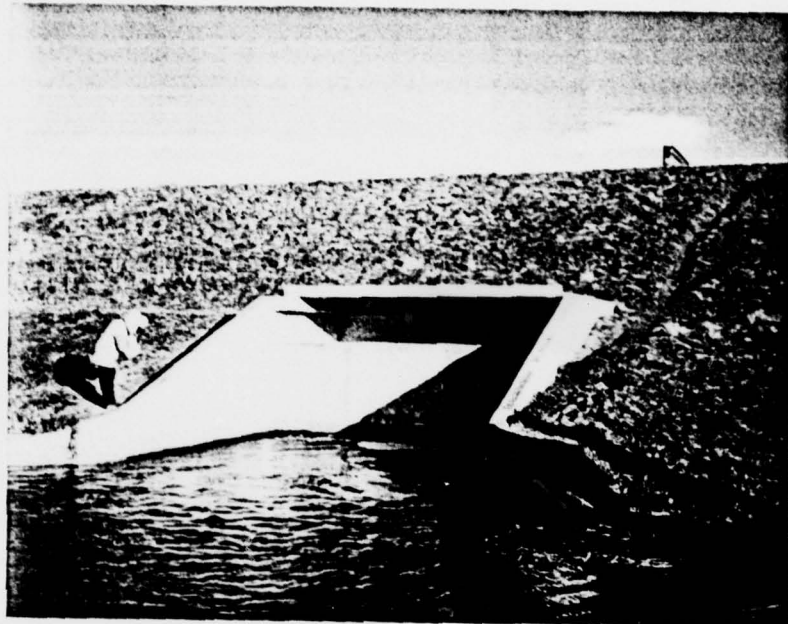
The only deleterious effect noted was the iron oxide staining and some light efflorescence where the conduit emerges from the headwall. The toe drain outlets were submerged and not visible during the inspection.

View of outlet structure

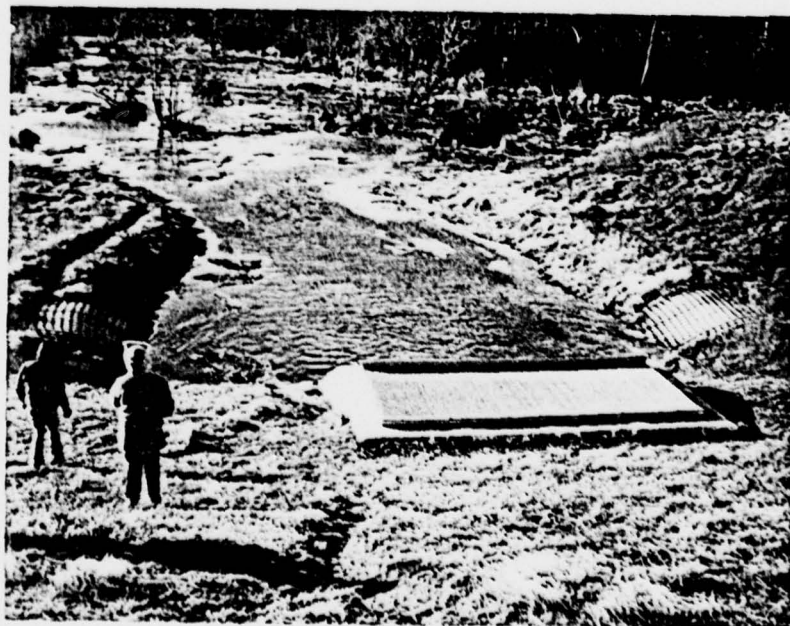
Downstream channel

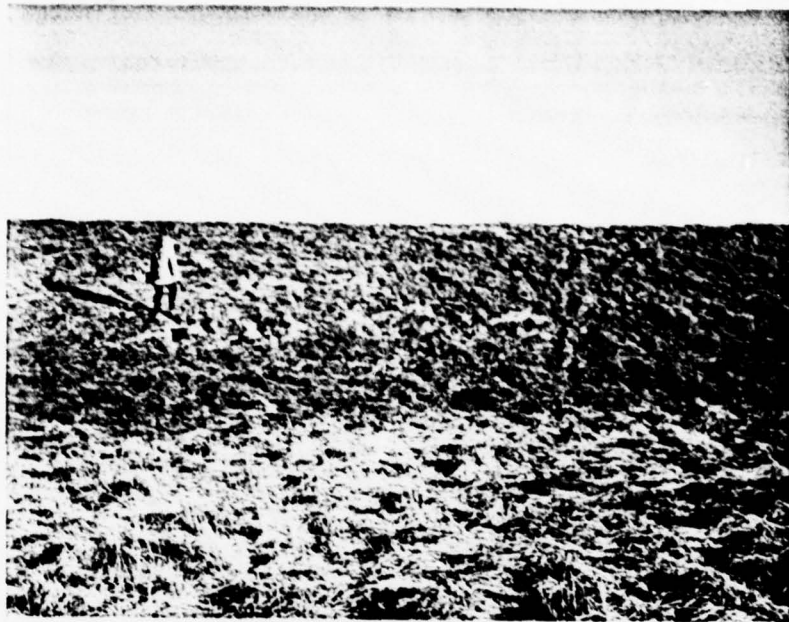
Erosion gullies in downstream face of dam

(1) Regrade the eroded crest backslopes and rutted portions of the auxiliary channel and reseed the bare areas.

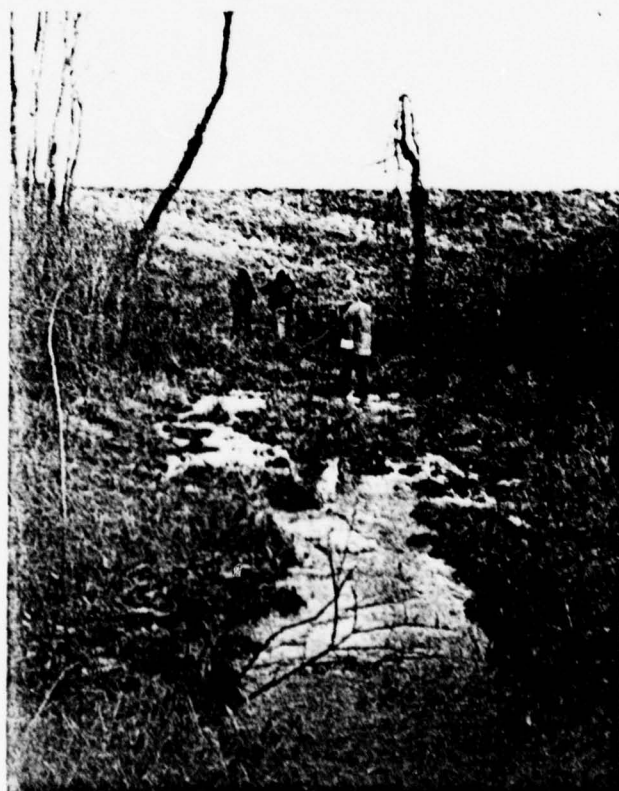
below the toe on both sides of the discharge channel were utilized as spoil disposal areas during construction and have a naturally high water table. The illegal use of vehicles on this soft, rather spongy ground has resulted in the creation of many deeply incised tracks now filled with water and ice. Additional evidence of the high ground-water table to the right of the impact basin was observed at several locations where small ponds were noted just beyond the toe of the dam. Although there are no seriously eroded areas, the vehicular tracking has done considerable damage and the water and ice in the ruts appear to be from seepage with the soil in the ruts wet and loose down to a depth of six inches. Another deep erosion gully which extends from behind the left wingwall of the impact basin to the crest of the dam appears to have been caused by trail bikes. Erosion behind the right wingwall is considerably less pronounced and of little consequence. Three stand pipes and a manhole are located along the downstream toe of the dam. These are part of the drain system which discharges through the wingwalls of the impact basin. The stand pipe at station 67+00 had water seeping out from under the cap (elev. 108+), suggesting a rather high pressure head on the drain system at this location.

Ponded water at toe of dam

(2) Continue to monitor the seepage and backslope drainage system. Records should be maintained of the hydrostatic heads in the standpipes to monitor any abrupt changes and to determine if further corrective measures are required.

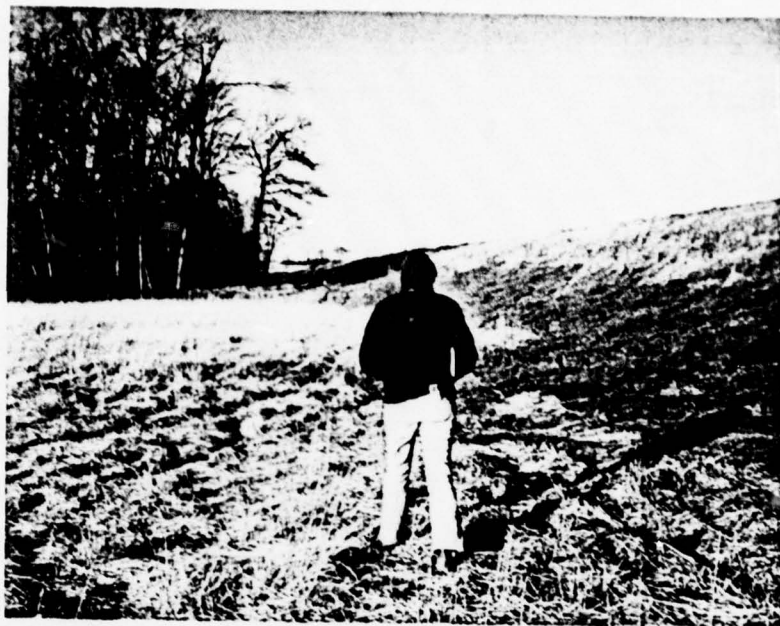
Vehicle tracks at toe

(3) Place additional barriers at various locations to inhibit the illegal vehicular use of the dam surfaces.

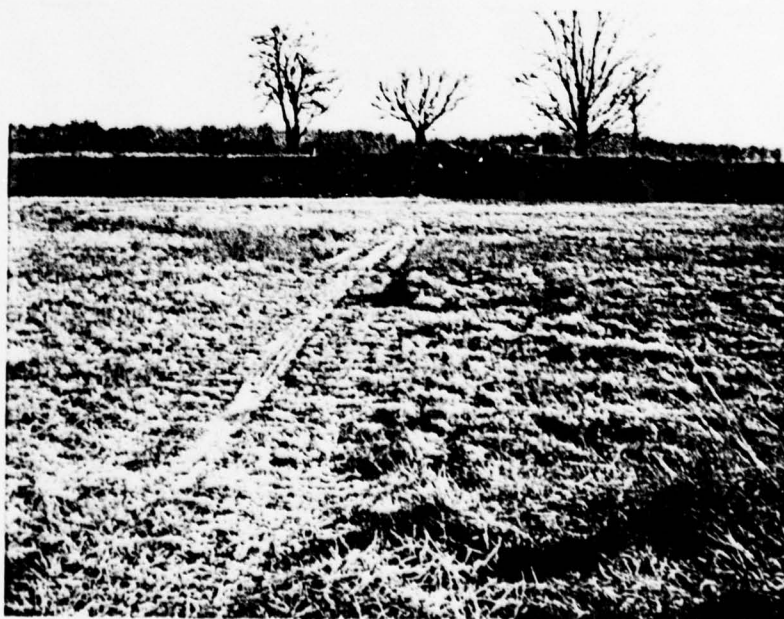
VISUAL EXAMINATION OF	OBSERVATIONS	REMARKS OR RECOMMENDATIONS
CONCRETE WEIR	None	Auxiliary spillway consists of wide grassy channel abutting left embankment.
APPROACH CHANNEL	Negatively sloped and grassy.	Erosion across channel and on both walls caused by vehicle tracks.
DISCHARGE CHANNEL	Positively sloped and grassy.	
BRIDGE AND PIERS	None

View of auxiliary spillway
